URGENT Medical Device Correction

Trilogy Evo, Trilogy Evo O2, Trilogy Evo Universal, and Trilogy EV300
Flow Sensor Nebulized Aerosol Deposition

03-October-2024

Reference: Flow Sensor Nebulized Aerosol Deposition
Trilogy Evo, Trilogy Evo O2, Trilogy Evo Universal, and Trilogy
EV300 2024-CC-SRC-013

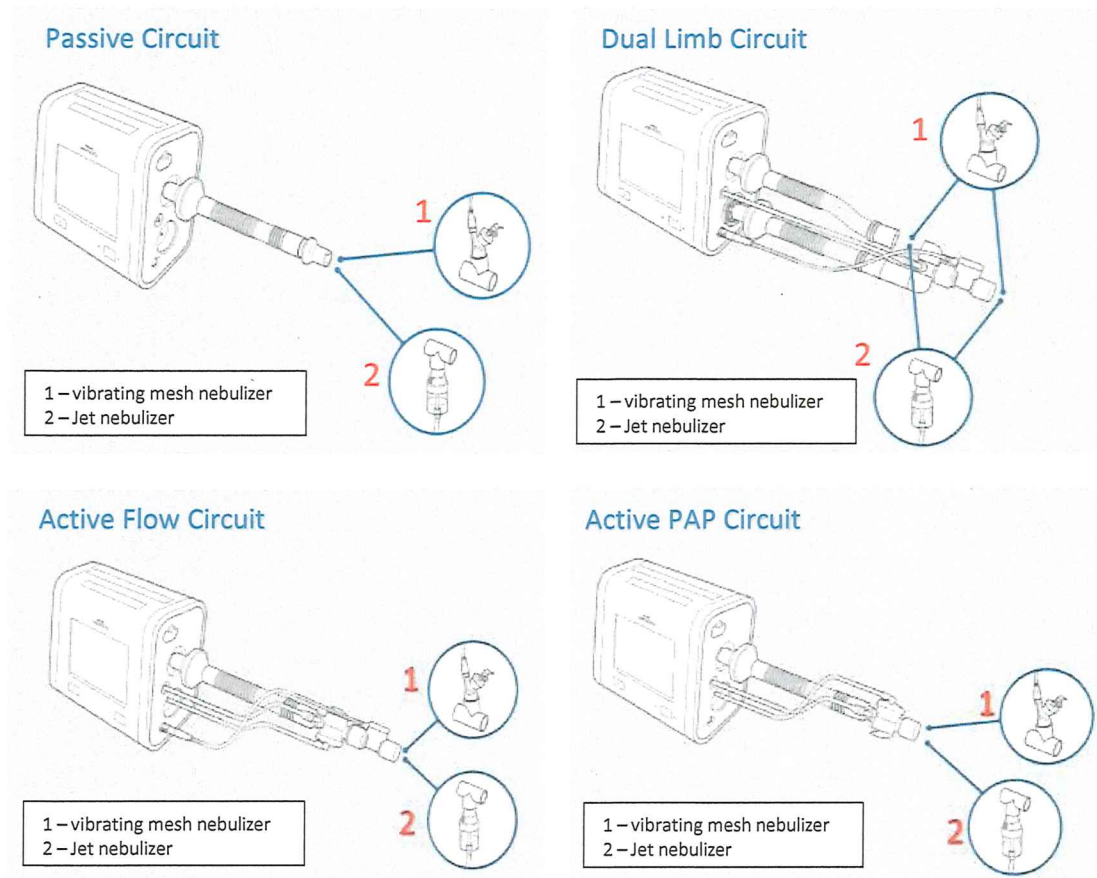
Figure 1: Acceptable In-Line Nebulizer Placement.

- When the in-line nebulizer is used with passive circuits for tidal volumes greater than or equal to 700 mL, or
- When the in-line nebulizer is placed at the dry side of the heated humidifier, or
- When the in-line nebulizer is placed at the “inspiratory port (to patient)” (device outlet), or
- When the in-line nebulizer is placed in any location *other than* those identified in the images in Section 4

- If using in-line nebulizer treatments:
 - The circuit must be configured as pictured in the images in **Figure 1** below
 - For prescriptions needing tidal volumes greater than 700 mL with a passive circuit, transition patient to alternate circuit (Active PAP, Active Flow, or Dual Limb).
