## URGENT NOTICE MEDICAL DEVICE RECALL

# Drive DeVilbiss Healthcare Car Charger Power Cord Accessory (provided with the iGo®2 Portable Oxygen Concentrator)

May 6, 2025

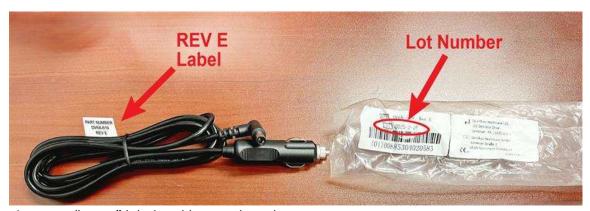
Figure 1: "Rev E" label and lot number placement

- Identify any inventory in your possession using the following identifiers:
  - a. model DV6X-619 Rev E car charger cords of lot numbers 2023-01-01 through 2024-12-31 (see Figure 1 below). <u>Not all Rev E cords are recalled; e.g.</u>: recently distributed Rev E labeled devices include a green sticker. These are assembled correctly and can be distributed.
